RE: Hotel Aiken Site Visit and Report

Hotel Aiken - Structural Assessment Summary

Hotel Aiken - Structural Assessment

235 Richland Ave. W, Aiken, SC

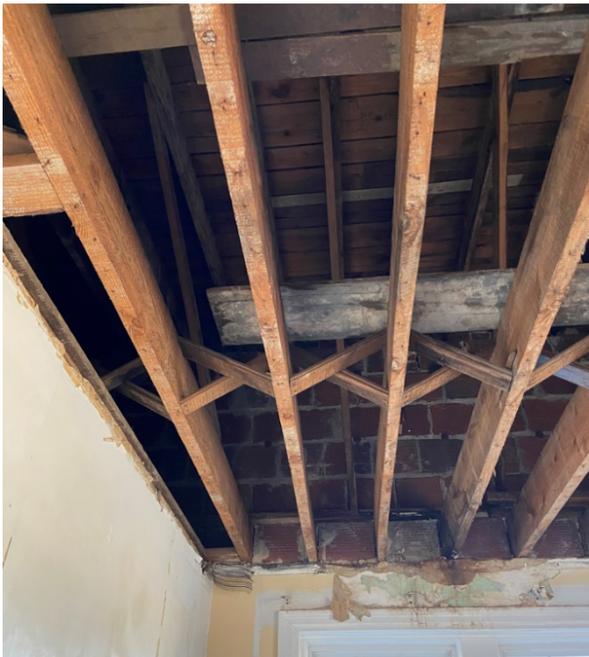
Roof framing spans perpendicular to the longitudinal walls of the building and consists of built-up trusses with 2x top and bottom chords and 1x web members. The roof diaphragm consists of 1x decking laid perpendicular to trusses. Generally, roof framing appeared to be in fair condition with the exception of framing along the south wall of the building and other isolated areas which indicated considerable water damage. Actual dimensions of roof framing were unable to be determined during the visit, but trusses are generally deeper at the North side of the building (Fig.1) and taper down towards the South to provide positive drainage to scuppers located on the South side of the building (Figs. 2-3). Evidence of water intrusion was noted along the south wall of the building (Figs. 2-3) suggesting ponding of rainwater along this wall. Significant water damage was also noted in isolated locations (Fig. 4).

Figure 1: Roof Framing at North Wall – Generally Fair Condition

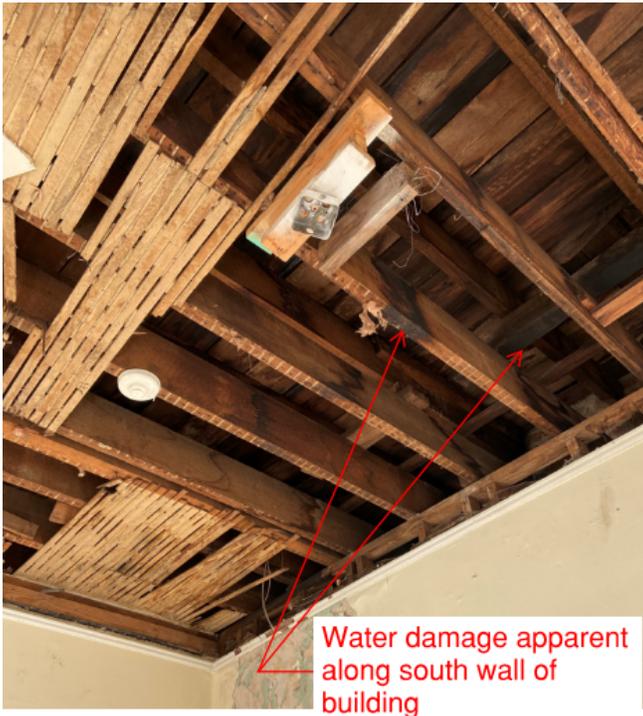
Figure 2: Roof Decking at South Wall – Generally Poor Condition

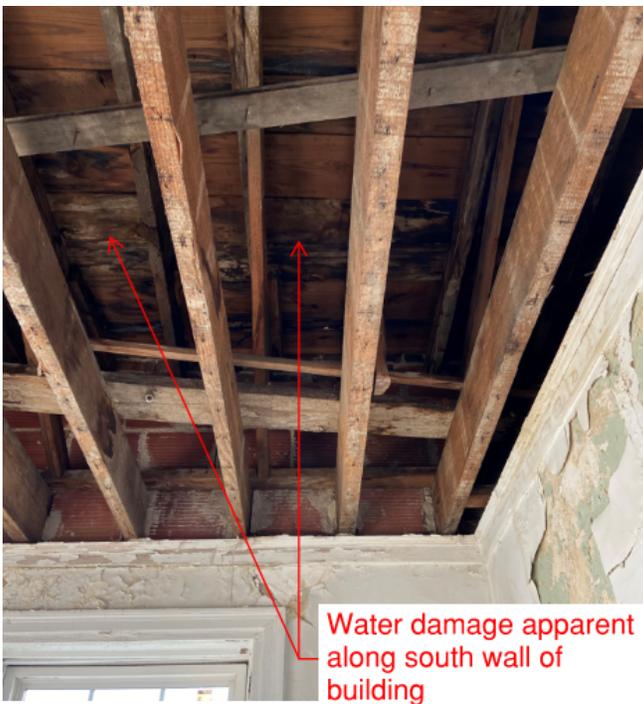
Figure 3: Roof Decking at South Wall – Generally Poor Condition

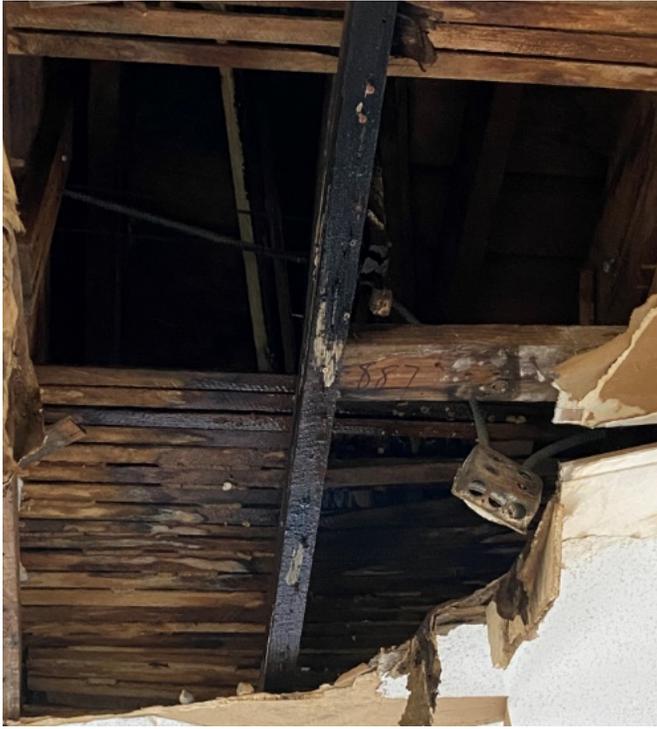
Figure 4: Roof Framing – Localized Substantial Water Damage

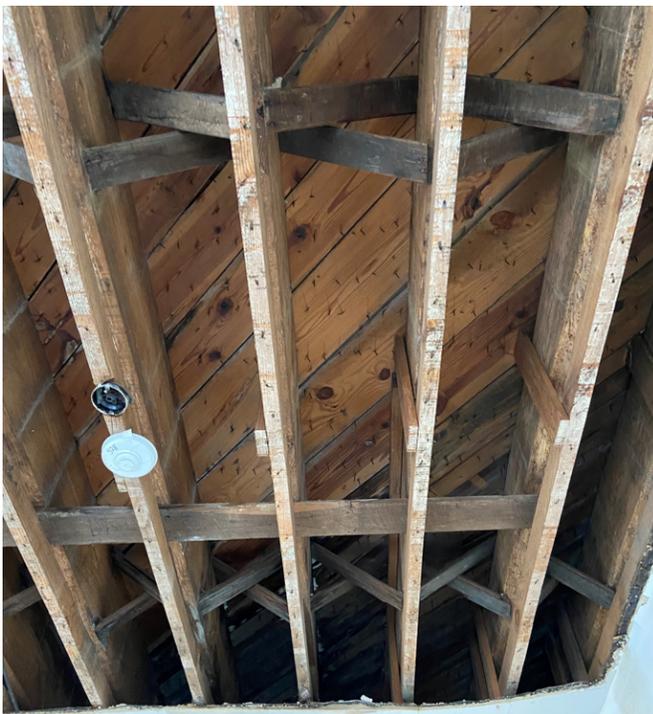
Floor framing is generally 2x12 or 3x12 rough cut joists varying from 16"-19"oc spanning from exterior multi-wythe brick walls to interior corridor walls except at the central stair location where joists span from demising wall to demising wall. The floor diaphragm consists of a 1x diagonal slat subfloor nailed to floor joists. In general, floor framing appeared to be in fair condition (Fig. 5); however, floor framing has been severely compromised in numerous locations, most notably at existing bathroom locations adjacent to corridors (Figs. 6-7). Further, due to excessive spans of up to approximately 24'-6", floor joists are inadequate to meet current design standards (see Structural Evaluation section).

Figure 5: Floor Framing – Generally Fair Condition

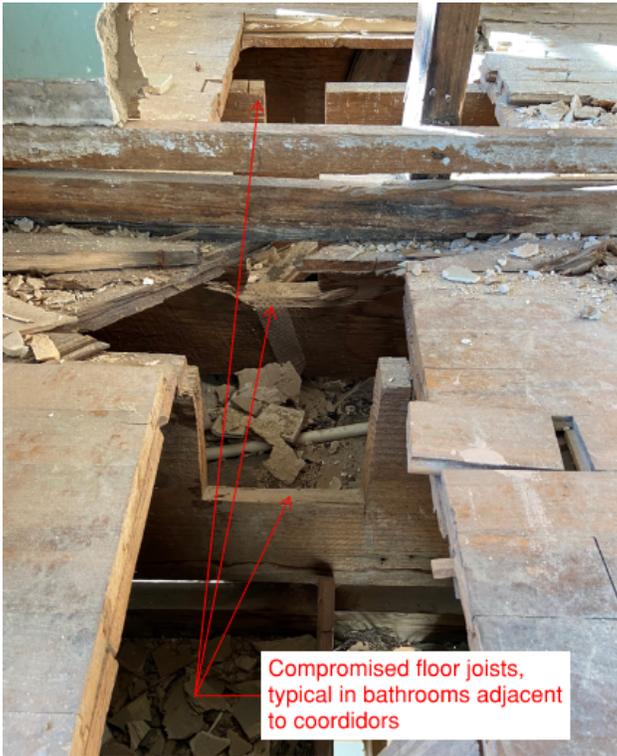
Figure 6: Floor Framing – Severely Compromised Adjacent to Corridors

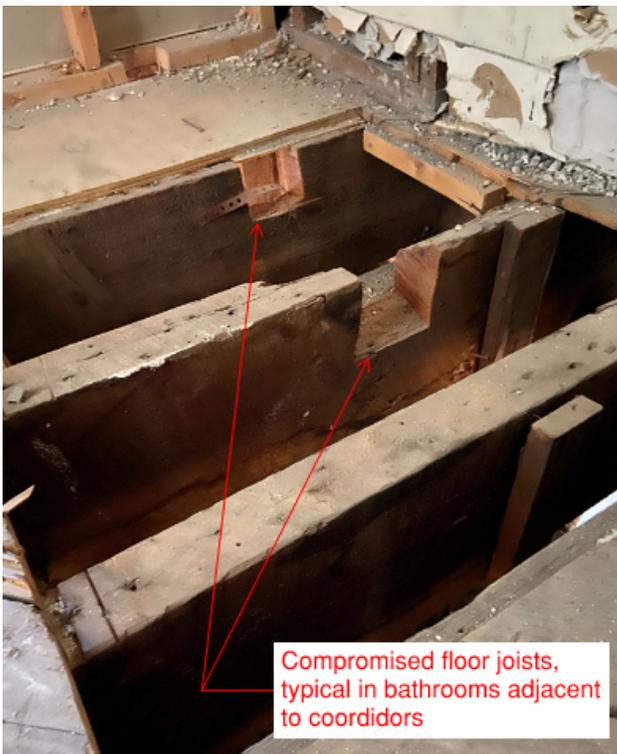
Figure 7: Floor Framing –Compromised Adjacent to Corridors

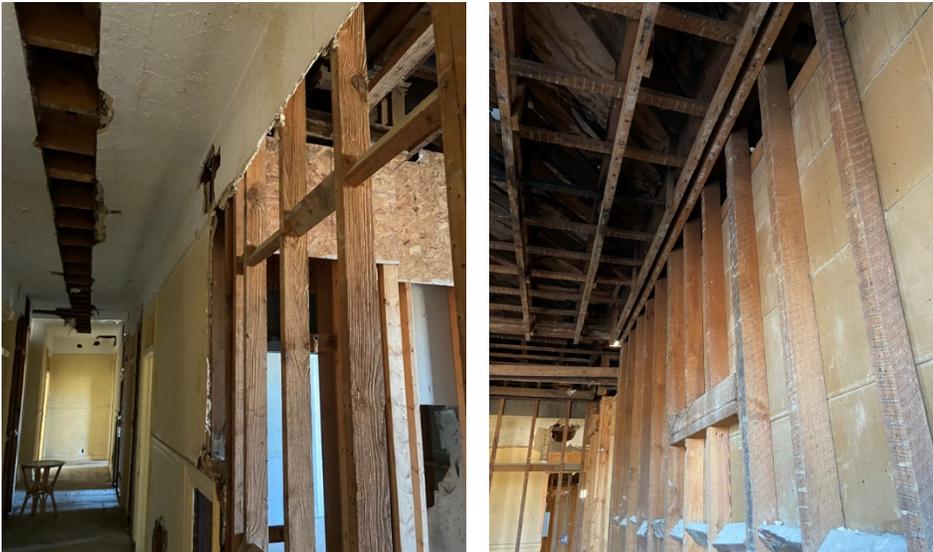
Stud wall framing was found to be rough cut 2x4s at 16"oc typical at all demising and corridor walls full height. Exposed studs at the time of visit were found to be generally in fair condition (Fig. 8) with localized areas that have been severely compromised (Figs. 9-11). Considering stud size and floor-to-floor heights, existing walls were determined to be inadequate to meet current design standards (see Structural Evaluation section). Localized areas of exposed studs were noted where substantial water damage (Fig. 9) and excessive modifications (Fig. 10-11) have severely compromised stud wall framing.

Figure 8: Interior Stud Wall Framing – Generally Fair Condition

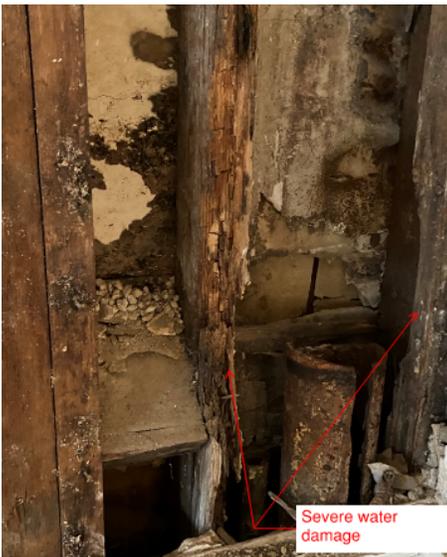
Figure 9: Severe Water Damage

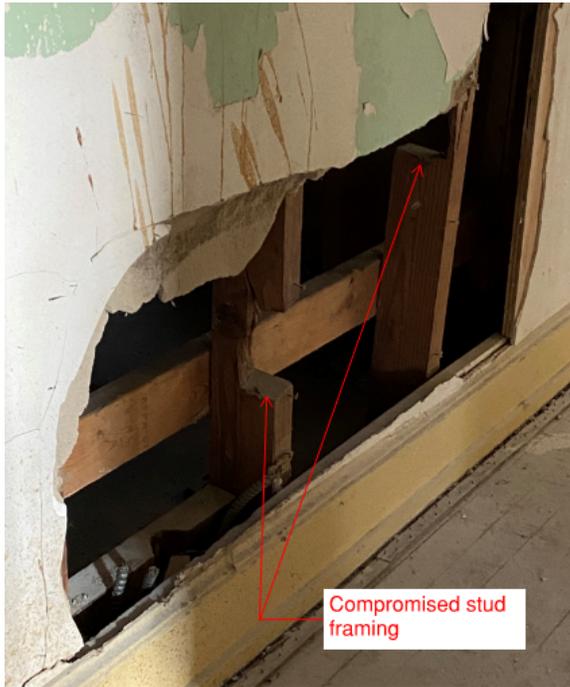
Figure 10: Compromised Stud Walls – Excessive Modifications

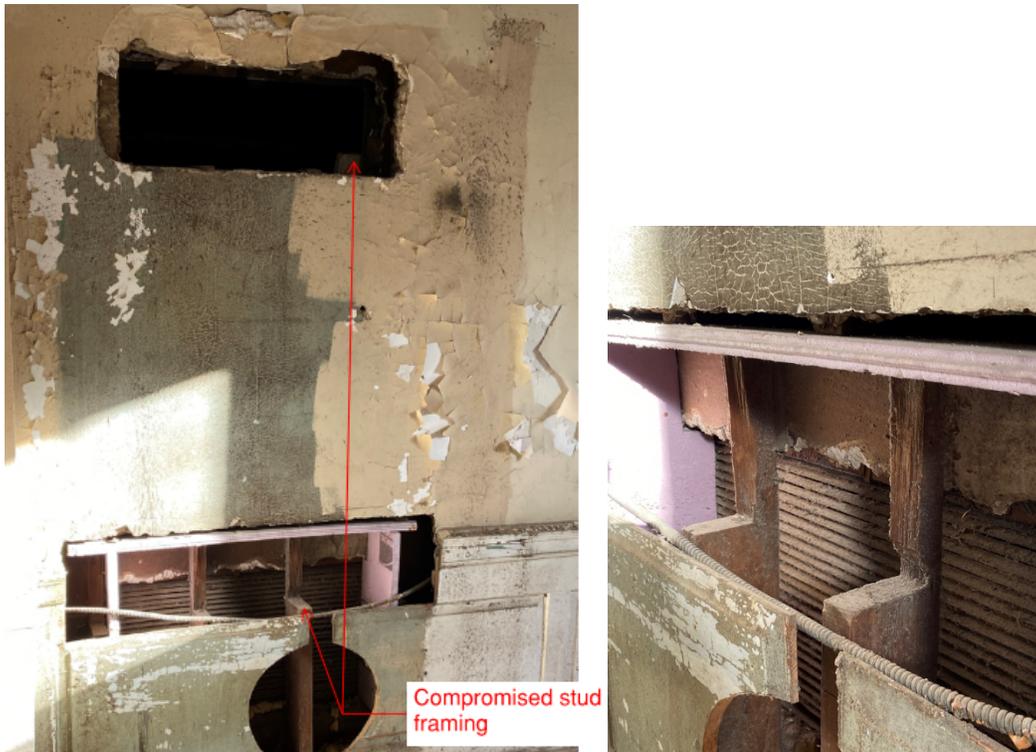
Figure 11: Compromised Stud Walls – Excessive Modifications

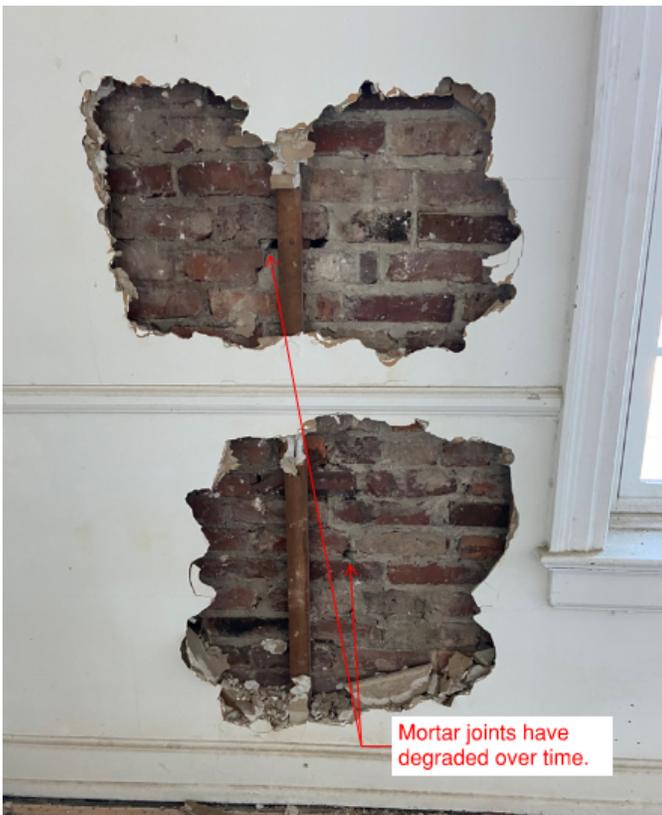
Exterior walls are multi-wythe brick unreinforced masonry (URM), and are load bearing along the longitudinal sides of the building. It was noted that exterior walls are thicker at the base and step in at upper levels of the building. Exterior walls were found to be in generally fair-to-poor condition (Fig. 12). Over time, mortar joints have degraded and the building has settled which has caused widespread cracking. This building would fall into Seismic Design Category C, and current codes require masonry walls to be tied into and braced against lateral environmental forces by building diaphragms. Such bracing was not found to be present (Figs. 13-14), which was expected considering the building's age; nevertheless, exterior walls should be mechanically fastened and braced at each floor level to restrain lateral forces should it be desired to occupy the building in the future. Outside the building, cracking present at numerous wall openings (Figs. 17-18) and severe cracking was noted in the Southeast corner of the building due presumably to excessive settlement (Figs 15-16).

Figure 12: General Exterior Wall Conditions – Fair-to-Poor Condition

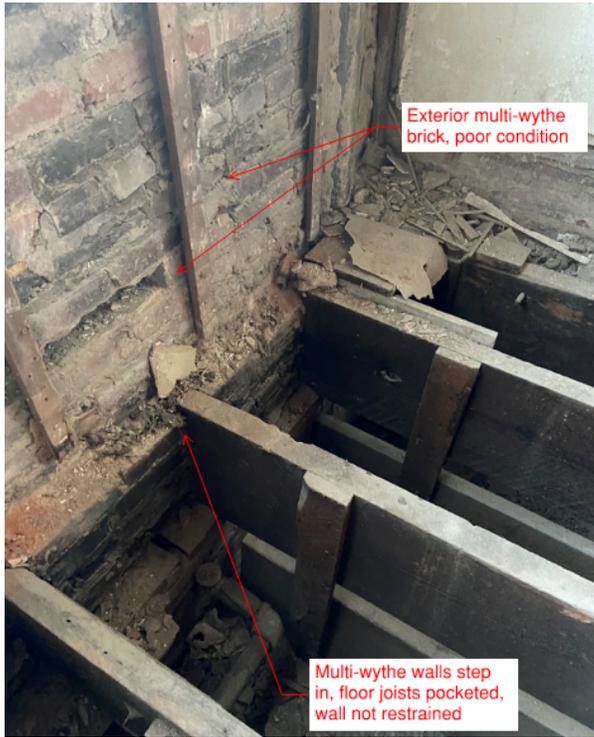
Figure 13: General Exterior Load Bearing Multi-Wythe Brick Wall

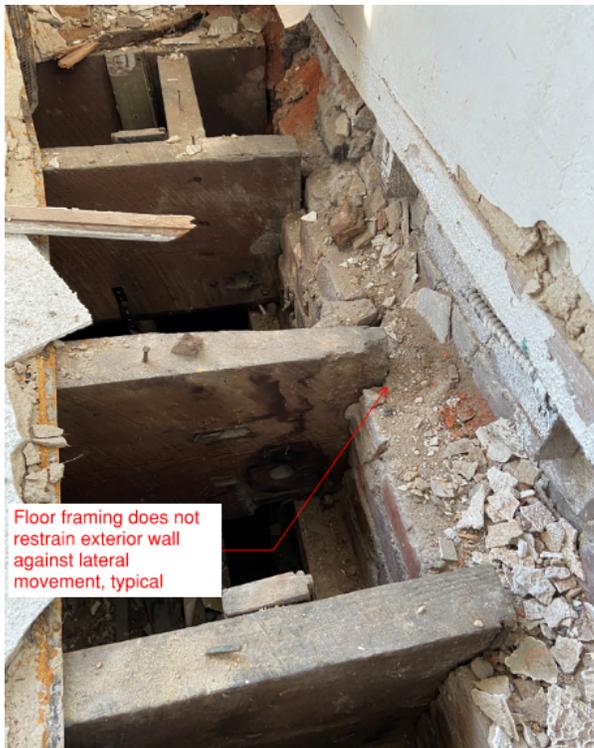
Figure 14: General Exterior Load Bearing Multi-Wythe Brick Wall

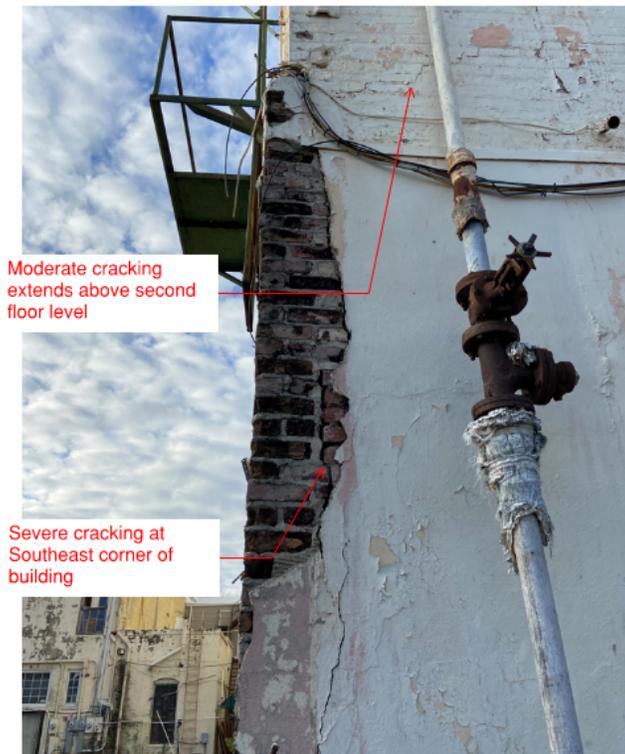
Figure 15: Southeast Building Corner – Severe Cracking

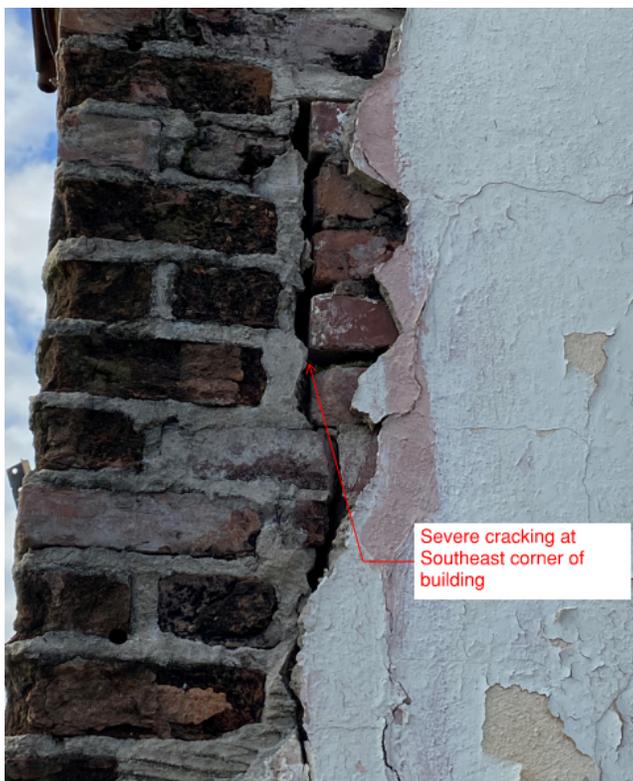
Figure 16: Southeast Building Corner – Severe Cracking

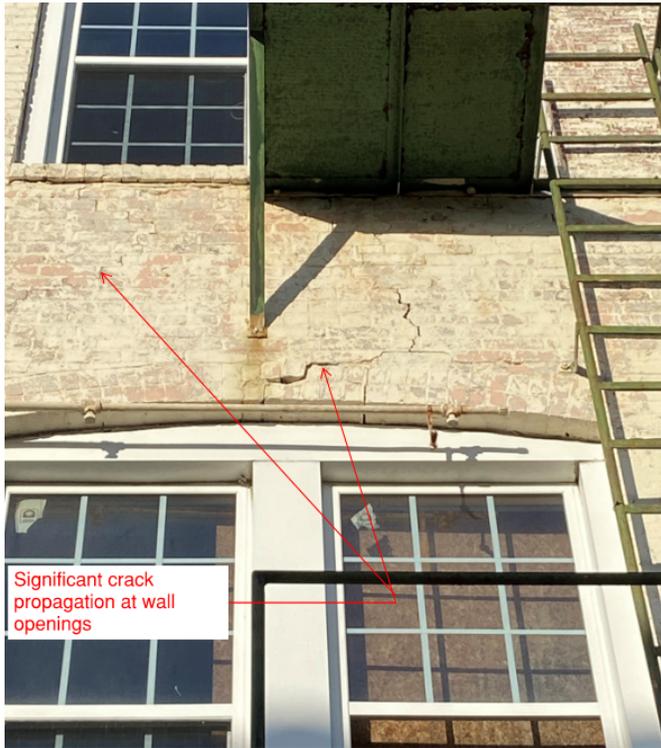
Figure 17: Crack Propagation at Window Openings

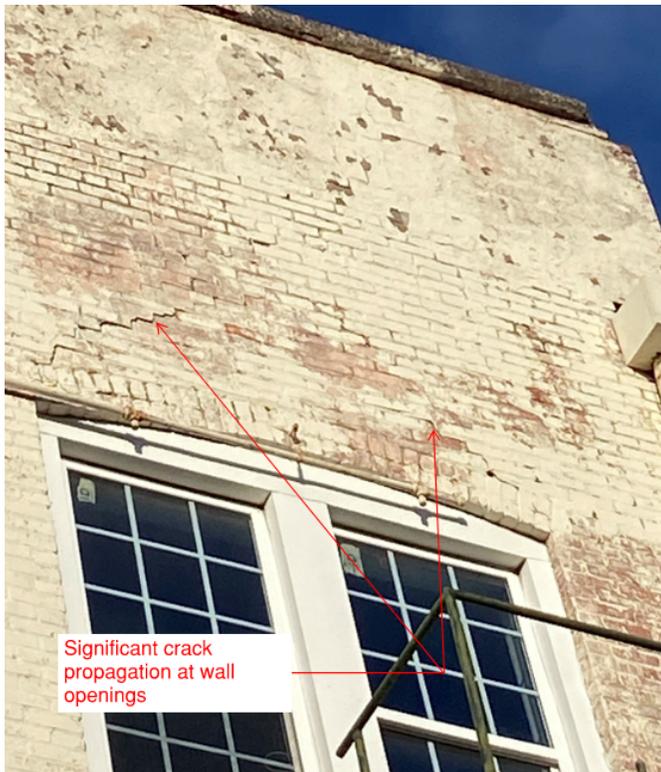
Figure 18: Crack Propagation at Window Openings

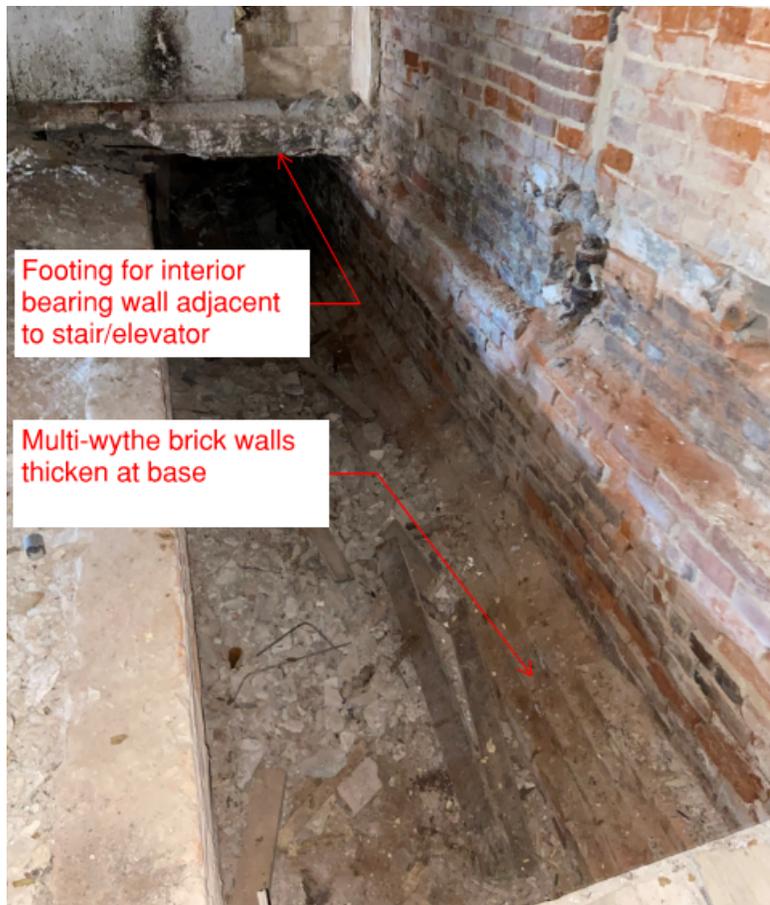
Existing footings (if present) were not exposed in most locations. Evidence suggests, however, that the multi-wythe brick walls thicken at the base of the wall to form a wider soil bearing area (Fig.19). This would be consistent with our experience with buildings of similar age and construction. There were also locations that indicate a mudsill was poured under masonry walls (Fig.20). Where observed, mudsills were 4-6 inches thick and appeared to be unreinforced (Figs 19-20). These bearing conditions, brick bearing directly on soil, or unreinforced mudsills are highly susceptible to differential settlement. As previously discussed, differential settlement is apparent in the Southeast corner of the building (Figs. 15-16) where significant cracking has occurred. It is likewise also probable that differential settlement due to inadequate foundations is responsible for generally poor wall condition along the longitudinal bearing sides of the building (Fig 21).

Figure 19: Base of Multi-Wythe Exterior Walls

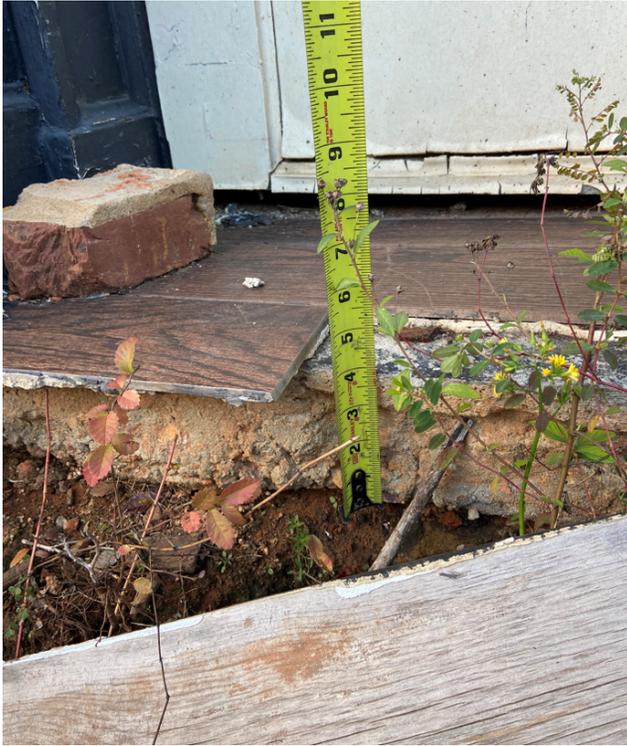
Figure 20: Mudsill Along South Wall Adjacent to Excessive Wall Settlement

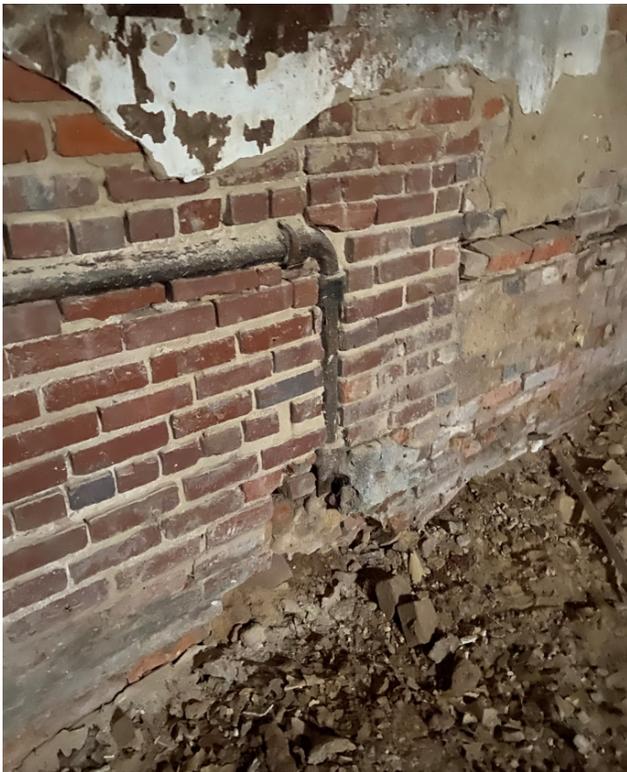
Figure 21: Inadequate Bearing Conditions

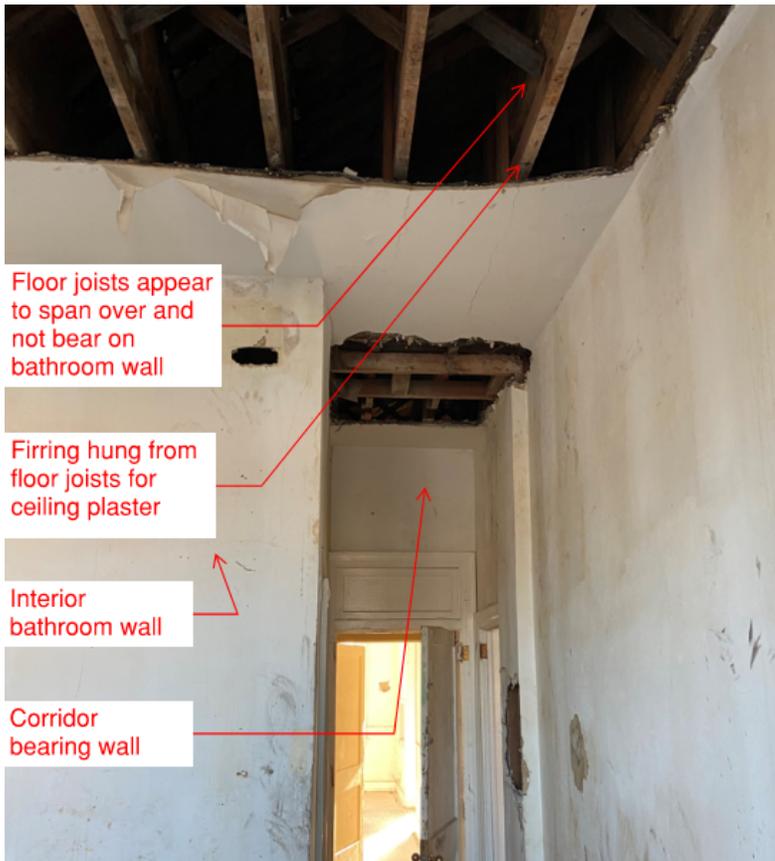
Figure 22: Floor Framing Appears to Fully Span from Exterior Walls to Corridor Walls

It should be noted that the longer span of 24'-6" was only observed at guestrooms on the north side of the building. A shorter span of approximately 18'-6" was observed at guestrooms on the south side of the building. 3x12 floor framing at 16"oc for this shorter span, 18'-6", was determined to be acceptable for intended loads assuming that joists have not been cut or modified (Figs. 6-7). It appears, however, that 2x12 floor joists (Fig. 22) were provided in places rather than 3x12 (Fig. 22). 2x12 rough cut joists were determined to be 10% overstressed for design loads at a span of 18'-6".

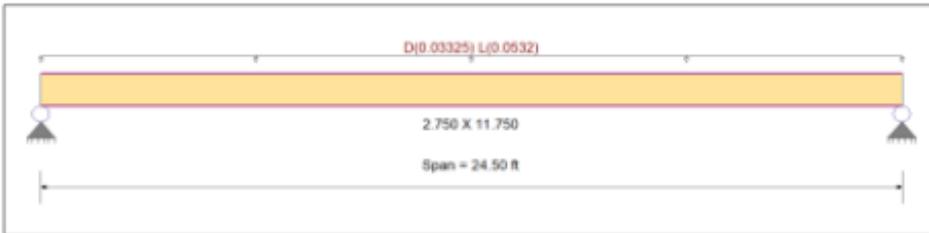
Figure 23: 3x12 Floor Framing Calculation Summary

A calculation summary is presented below for 3x12 rough cut joists at 16"oc spanning 24'-6" (Fig. 23). In the calculations below, dead load is considered to be 25 psf, and live load is 40 psf. Floor framing as described above is considered to be more than 20% overstressed per current design standards.
